# Catchment Characterisation Survey

## Electrofishing Report, Summer 2016

Project	Report No.	Revision No.	Date of Issue
Catchment Characterisation	002	001	April 2017

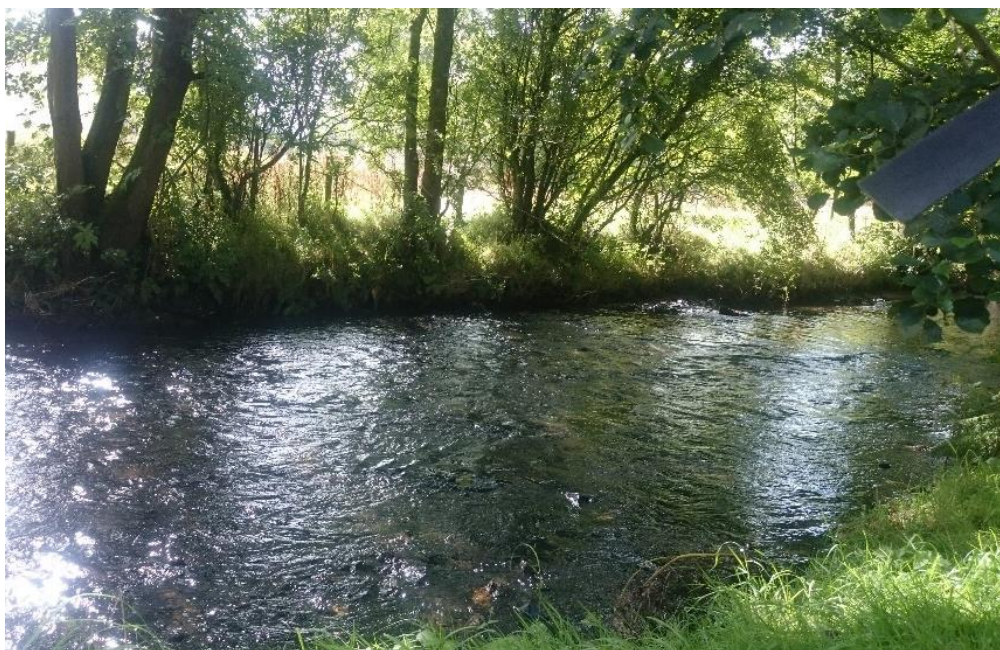
*Figure 14.* An example of a survey site classified as Maintain, with dappled shade, gravel provision, minimal silt and a fenced riparian strip.

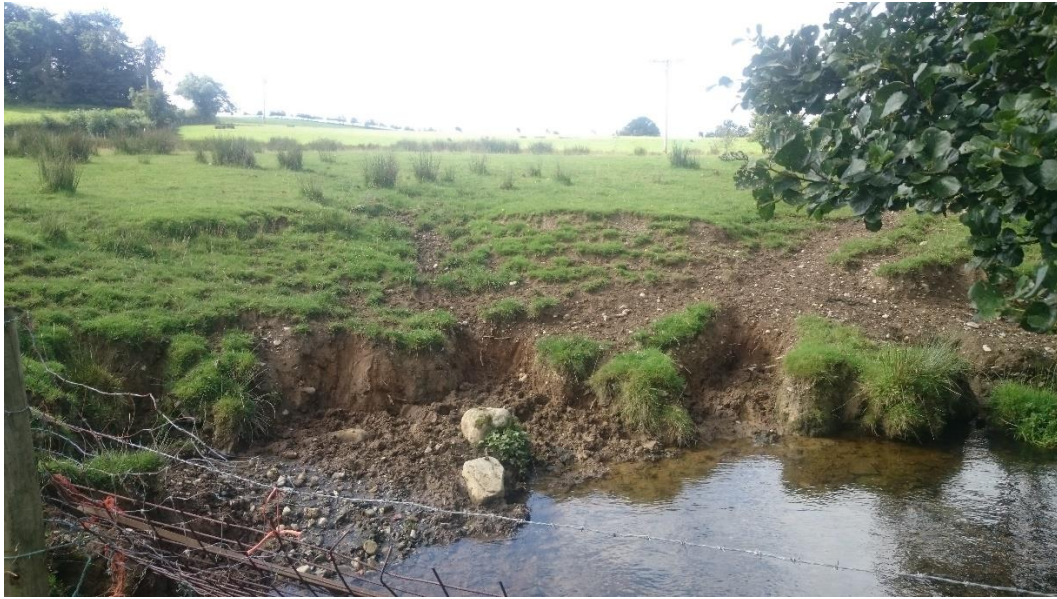
*Figure 15.* An example of a survey site classified as Repair, which currently has erosion problems caused by livestock access, but could easily be repaired with fencing and willow spiling or tree planting.

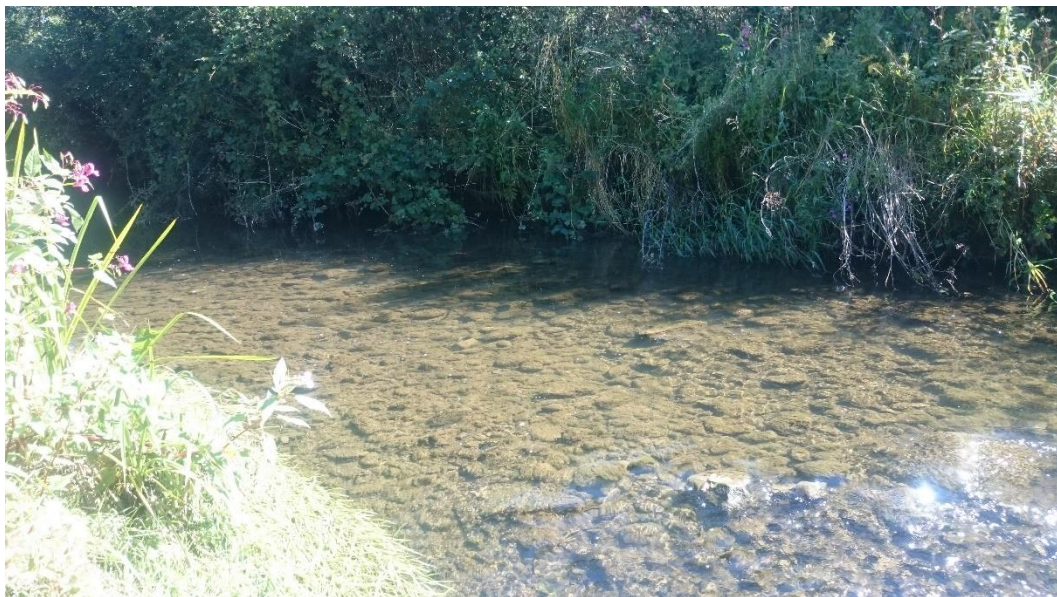
*Figure 16.* An example of a survey site classified as Restore, which has a major siltation problem, invasive species such as Himalayan Balsam present, no shade from trees and minimal riparian fencing for livestock.

- 3.4.1 The survey sites were scored using a weighted scoring system, with higher scores meaning better habitat for fish. For example the highest scoring sites had large riparian width, dappled shade, and no stock access, gravel provision with minimal silt, no barriers, no invasive species, and large wooded debris provision.
- 3.4.2 These scores were then split into three categories which were defined as requiring the following levels of work to provide the best habitat for fish;
- **Maintain** - limited small scale work required such as insertion of large woody debris or tree maintenance (for example, Figure 14)
  - **Repair** - modest work such as fencing off buffer strips, provision of new gravels, willow spiling and tree planting (for example, Figure 15),
  - **Restore** - major restoration works such as re-routing the channel required (for example, Figure 16).
